## Retrofitting of the Faculty of Electrical Engineering Building, Poznan University of Technology, Poland

### 2 Project summary

The project described includes retrofitting of the building envelope (new windows and improving the U-values of walls) and the modernisation of the heating system.

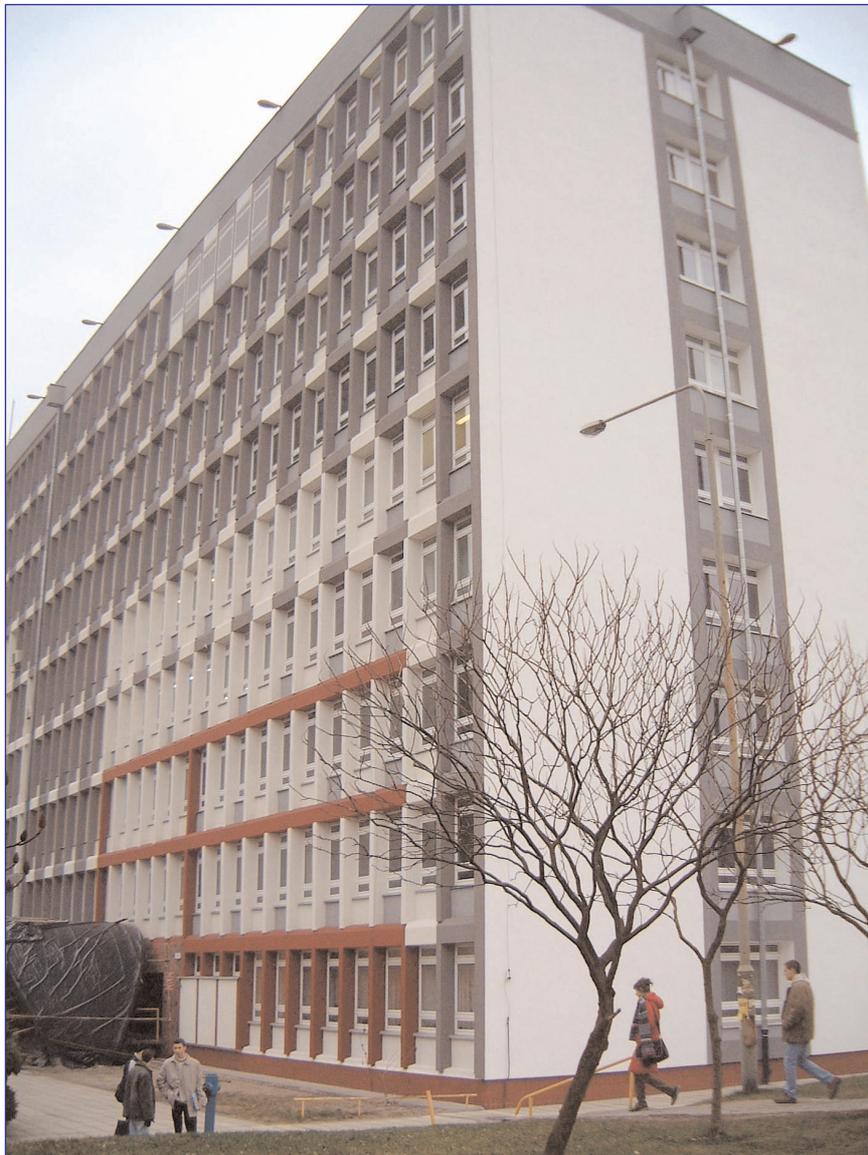
**Figure 1:** Faculty of Electrical Engineering Building after retrofitting

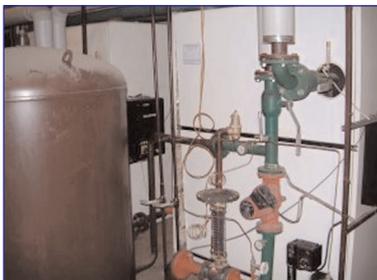
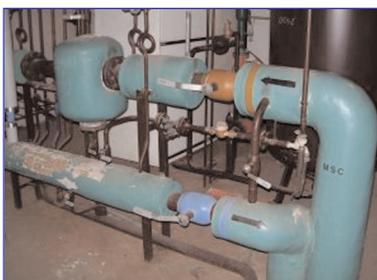
Hot water, two pipe, up-feed, pressurised central heating system with circulation pump and cast iron radiators. Distribution system is divided into two sections (western and eastern), each supplied from the city heat distribution network through the heat exchangers' plant. The lack of thermostatic valves caused random room temperatures and drafts - the only method of temperature regulation was to open or close a window, which sometimes affected air quality.

The main goal was to minimise heat losses by improving the building envelope. To assure temperature control in sealed rooms all radiators were equipped with thermostatic valves.

Every plenum heater was equipped with a thermostatic valve.

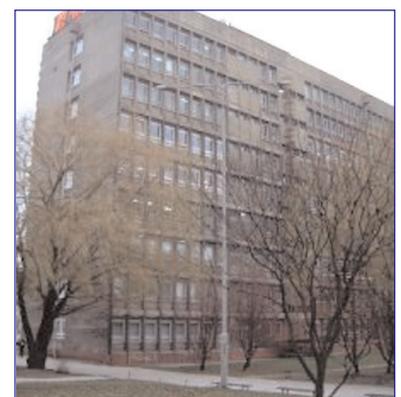
Below: The twin building - Faculty of Mechanical Engineering Building (the same appearance as the Faculty of Electrical Engineering Building before retrofitting)

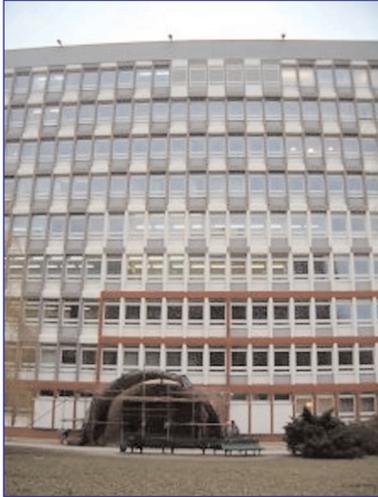
Faculty of Electrical Engineering  
Building after retrofitting.
