Refurbishment and extension of Gambetta professional high school, France

FR2

Annex 36: Case Study Report

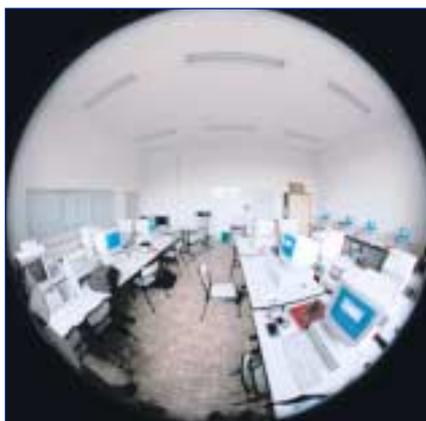
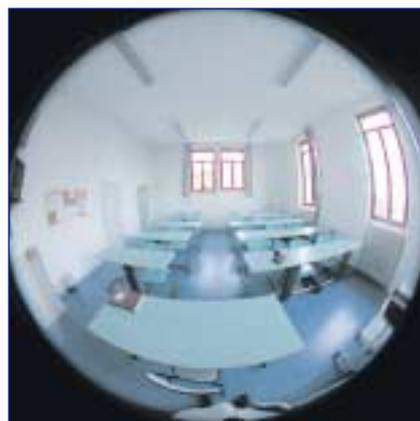
Figure 4: Far left: View from the blackboard
 Left: View from the openings

Lighting: A lighting diagnosis has been conducted in 4 classrooms (2 computer rooms located on the first floor and 2 classrooms on the second floor). The opening index (ratio glazing/total area) is between 11% and 22%.

We also noticed the following problems:

- Insufficient daylighting level at the deeper areas of the rooms where the daylighting factor is below 2%.
- deficient or insufficient solar protection systems
- In some classrooms, the power of artificial lighting installed is above the recommended value by the French Requirements

Bad: Problems of reflections or glare from the blackboard.

Additional or more efficient solar protection system and optimized lighting controls with more efficient luminaires could decrease the brightness and avoid solar overheating.
