Energy Conservation in Buildings and Community Systems, Annex 36 Case studies overview

# 1. Energy-Efficient Retrofit of the Käthe-Kollwitz-School in Aachen, Germany

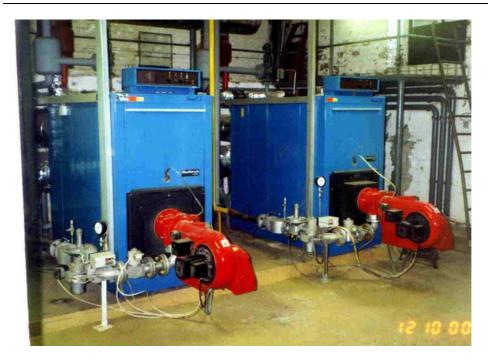
Figure 3: Photo of the gas burners before the retrofit

The existing central heating system was supplied by two gas burners with each 500 kW load. The heat delivery was managed by fluted radiators made of steel or cast iron. Not all rooms had thermostats.

During the retrofit the existing two gas burners with a load of 500 kW each will be removed and the supply will be transfered to the district heating system. The single pipe systems will be replaced by a double pipe system and parts of the existing heating elements will be removed since the heat load will be much smaller. The domestic hot water will get a smaller water storage with a volume of 300 l. Formerly the school had two storage vessels of 1000 litres each. The reduction was proved to be optimal by measurements.

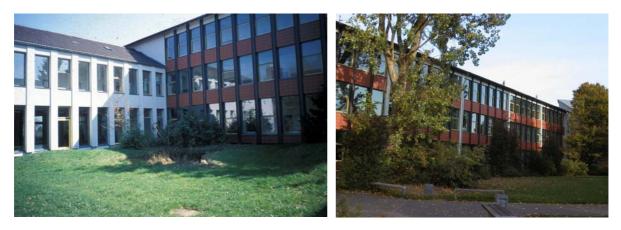
Figure 5: Photos of the auditorium (left) and the administration block (right) after the retrofit.
