1. Energy-Efficient Retrofit of the Laboratories in Juelich, Germany

1.2 Project Summary

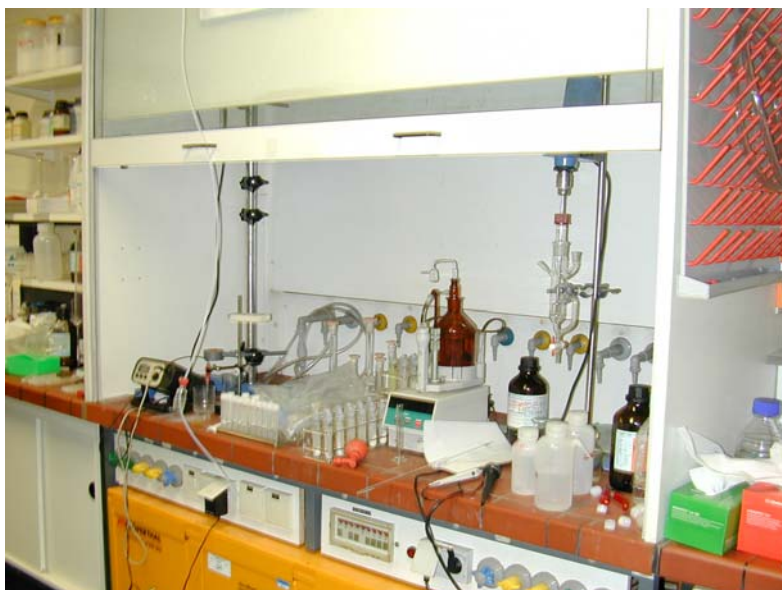
Figure 4: Laboratory exhaust system

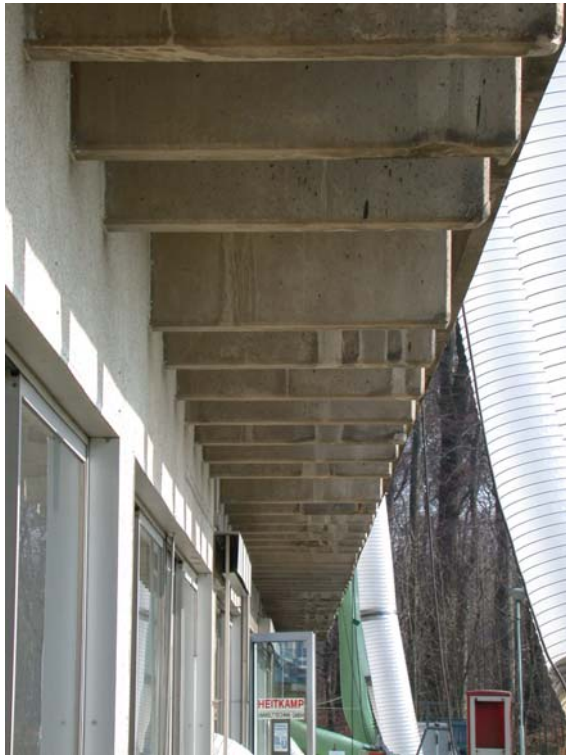
Figure 5: Thermal bridges caused by brackets under the escape balconies.

Since most of the energy was used for the air-conditioning of the laboratories, the retrofit concept deals mostly with improving the efficiency of the heating and ventilation system and with decreasing the ventilation rate. Additional retrofit measures were planned for the building envelope and the lighting equipment. Special care has to be taken on the thermal bridges of the escape balconies.

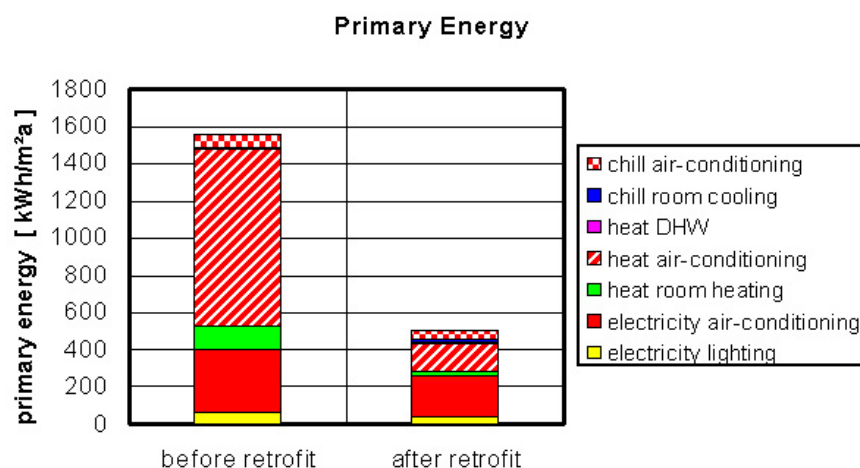
Figure 6: Monitored energy consumption before and calculated demand after the retrofit.

The current primary energy consumption of the building amounts to 1558 kWh/m²a. Out of that 1372 kWh/m²a are needed for the air-conditioning and ventilation of the rooms, 126 kWh/m²a for additional heating, 58 kWh/m²a for lighting and 1,6 kWh/m²a for domestic hot water.

The retrofit will decrease the primary energy demand to less than a third (502 kWh/m²a) by focusing mainly on the demand for air-conditioning and ventilation (412 kWh/m²a).
