Retrofitting of the Rural and Surveying Engineering Building, N.T.U.A., Athens, Greece

GR3

Annex 36: Case Study Report

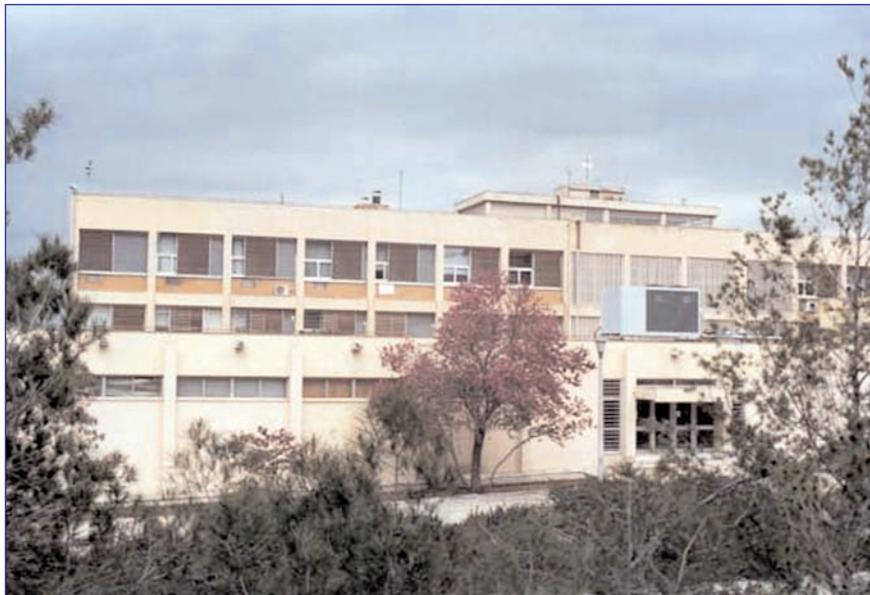
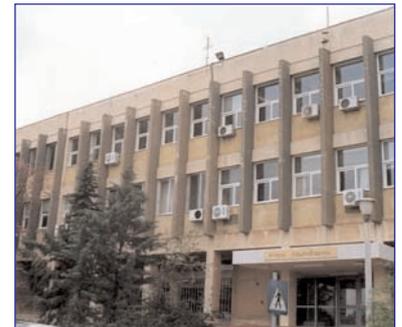
Figure 1: Left: South view of the building before retrofit
Above: View of the north side before retrofit

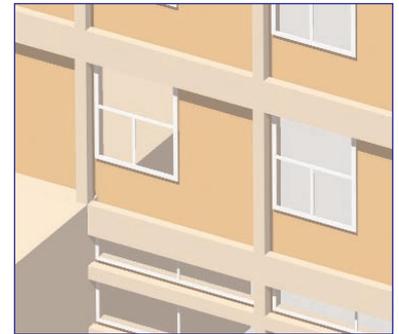
Section of the South façade before retrofitting

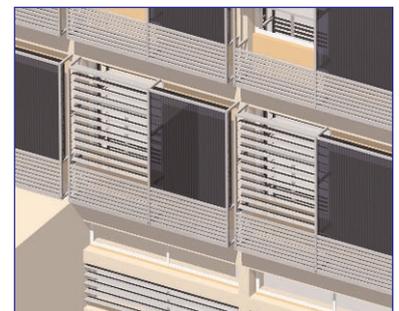
Combination of retrofitting interventions - shading devices and thermosiphonic panels
