## Retrofitting of Borgen Secondary School, Norway

## Annex 36: Case Study Report

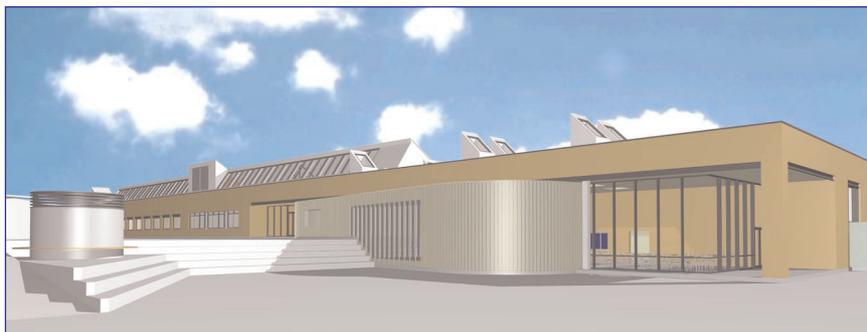
**Figure 1:** Artists impression of completed retrofit.

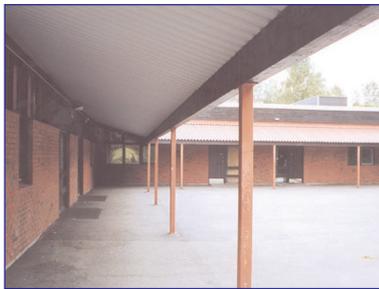
Figure 2: Borgen School before retrofit.

The original building had a brick facade. The striking renovation to the building includes a new facade and roof. Due to new regulations on snow load, the roof had to be rebuilt. The old roof also resulted in minimum daylight inside. Original windows were small and did not meet today's standards for thermal insulation. The main construction of the old building also had to be strengthened. The layout of the schools was inconvenient with no communication lines and needed to be totally changed.
