Research and teaching buildings at the University of Stuttgart, Germany

2 Project summary

Annex 36: Case Study Report

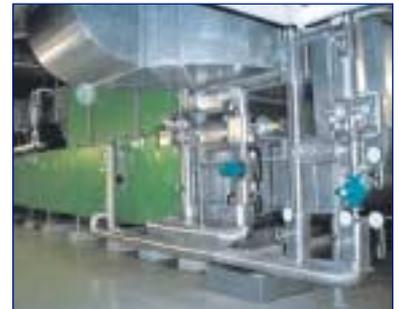
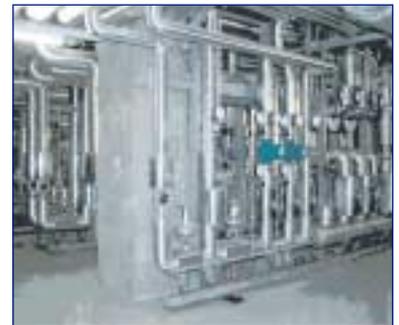
- Retrofit of DDC Control
- Installation of new DDC/GLT System
- Installation of 100 temperature and humidity sensors to measure heating needs
- Replacement of oversized motors for ventilation
- Optimisation of ventilation strategies
- Measurement of CO₂ to adapt ventilation to utilisation needs
- Utilisation of internal heat gains
- Optimisation of heat recovery
- Optimisation of cooling and heating according to actual user requirements
- Continuous energy monitoring
- Continuous training of operators
