## Egebjerg School, Ballerup, Denmark

### 2 Project summary

Annex 36: Case Study Report

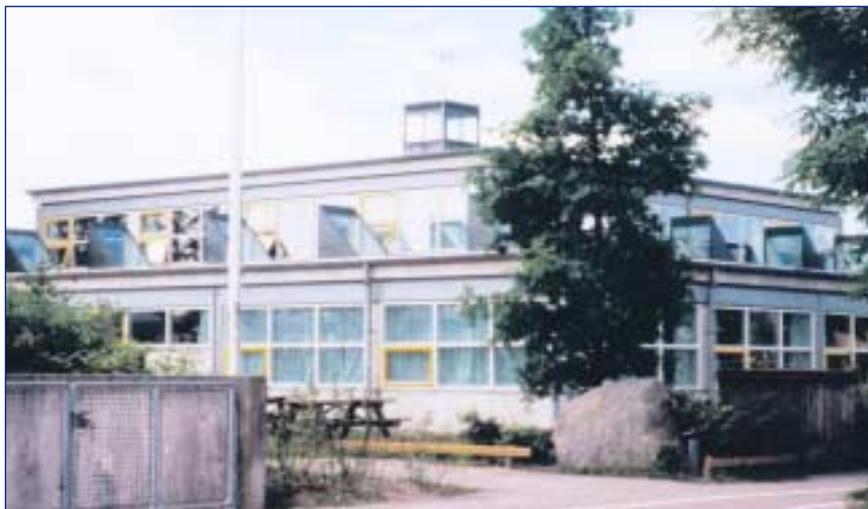
**Figure 1:** Photo of the school, north view showing retrofitted rooflights.

Advanced roof lights. The roof lights have a vertical part for direct sunlight (primarily turned towards the south) and a sloping part towards the sky for diffuse light. In the light shaft a special arrangement of a light-diffusing grid prevents glare in the classrooms.
