Replacing mechanical ventilation with natural ventilation at Enghøjsskolen school in Denmark

2 Project summary

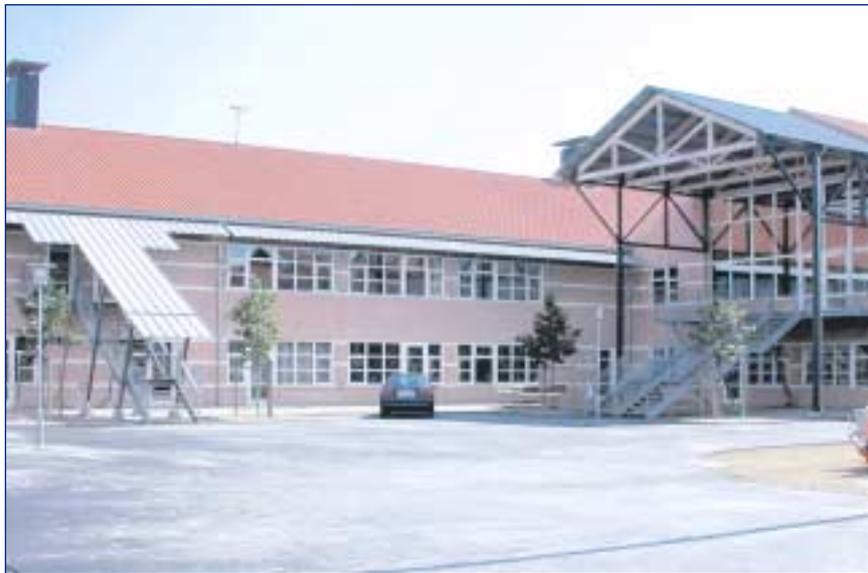
Figure 1a: Photo showing the facade of Enghøjsskolen

Worn-out installations and structures in Enghøjsskolen, a Danish school in Hvidovre, situated just outside Copenhagen, made it necessary to carry out a comprehensive renovation. Façades, roofs, windows and all materials for inner surfaces were replaced. Teachers, students, parents, consultants and school maintenance staff decided in co-operation that the old ventilation system should be replaced by hinged windows only. This would allow school users to open the windows when required. Furthermore some of the ceiling and façade windows should open by motor control when temperatures increase and when the school bell sounds for recess. This way, windows would be open at least 10 minutes every hour of the school day. Moreover the ceiling height was increased in classrooms by replacing the original flat roofs with pitched roofs parallel with the ceilings. Prior to the renovation, walls had acrylic paint and floors were covered with linoleum. New and similar materials were used in the renovated school.

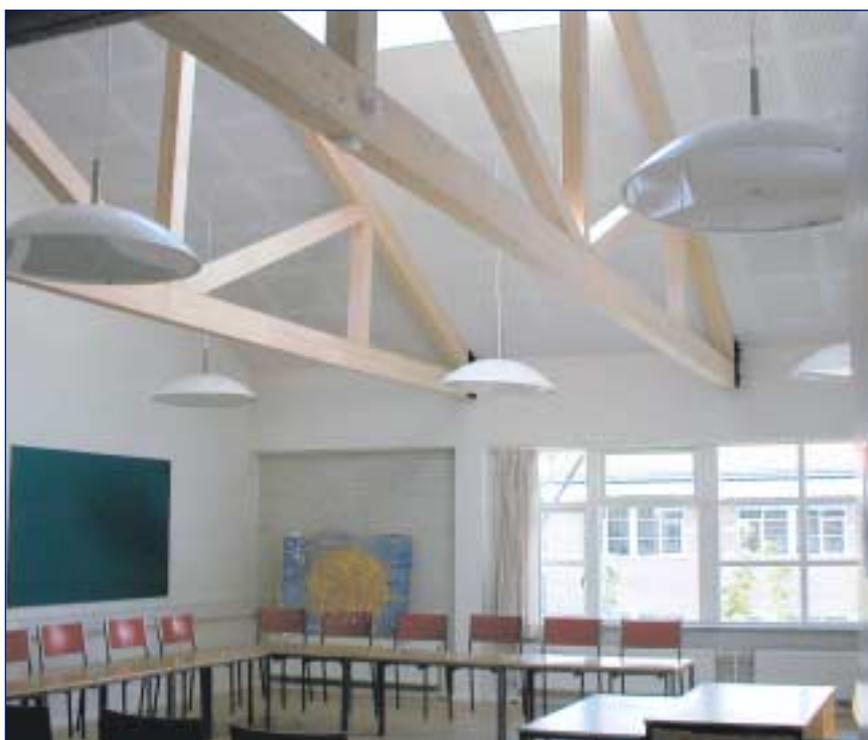
Figure 1b: Photo showing the interior of Enghøjsskolen
