Elementary school of Oulujoki, Finland

2 Project summary

Annex 36: Case Study Report

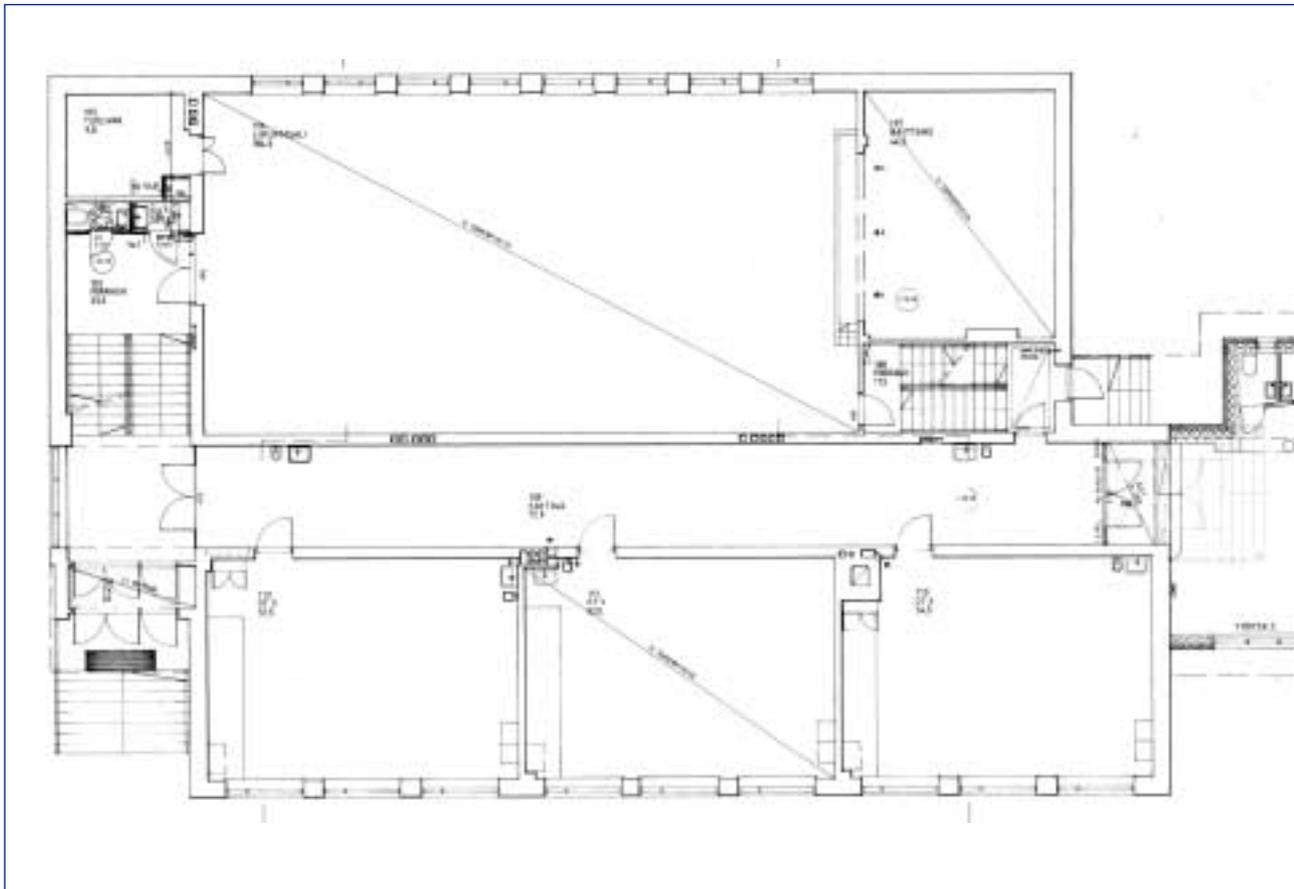
Figure 2: Floor plan: general layout of the 1st floor main building - gym and classrooms

The school is a typical 3 storey central-corridor school, built in the 1940s. The school consists of two buildings. One building was formerly a hostel for the students but is now converted into classrooms and teachers' rooms. The school is a brick construction with insulation in the cavity between the brick layers. The windows are mainly triple glazed with wooden frames. The earlier school building was connected to the hostel facility with a gateway in 1990. The ventilation system was changed from a natural ventilation system to a mechanical ventilation system with heat recovery. No other renovation measures have been carried out at this stage.

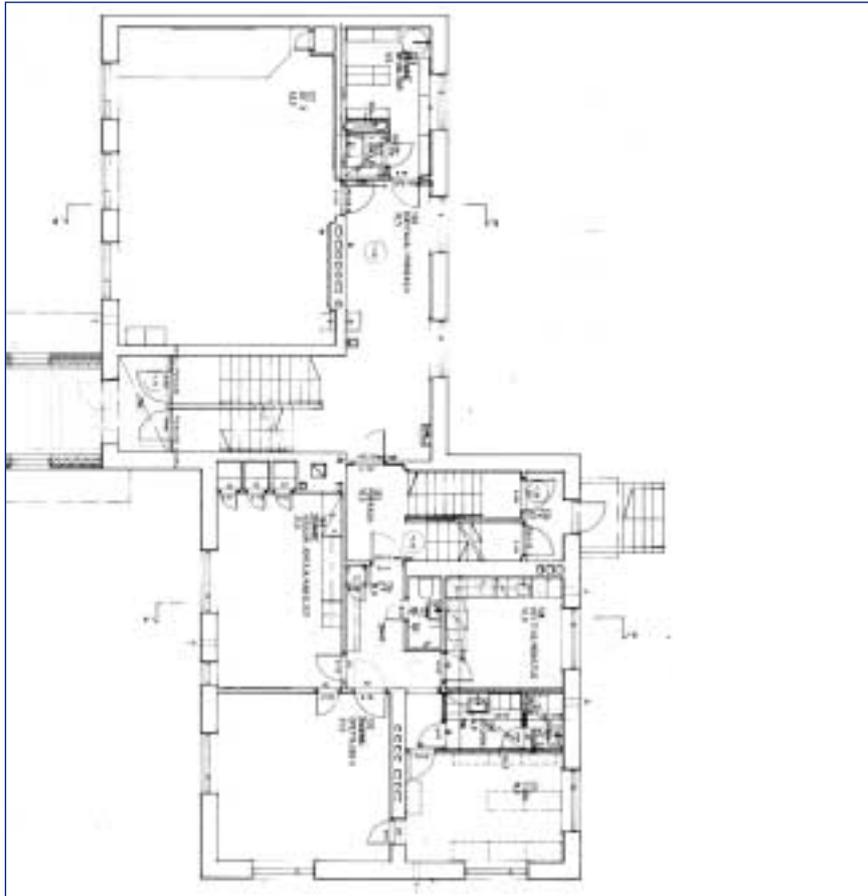
Figure 3: Floor plan: general layout of the 1st floor side building

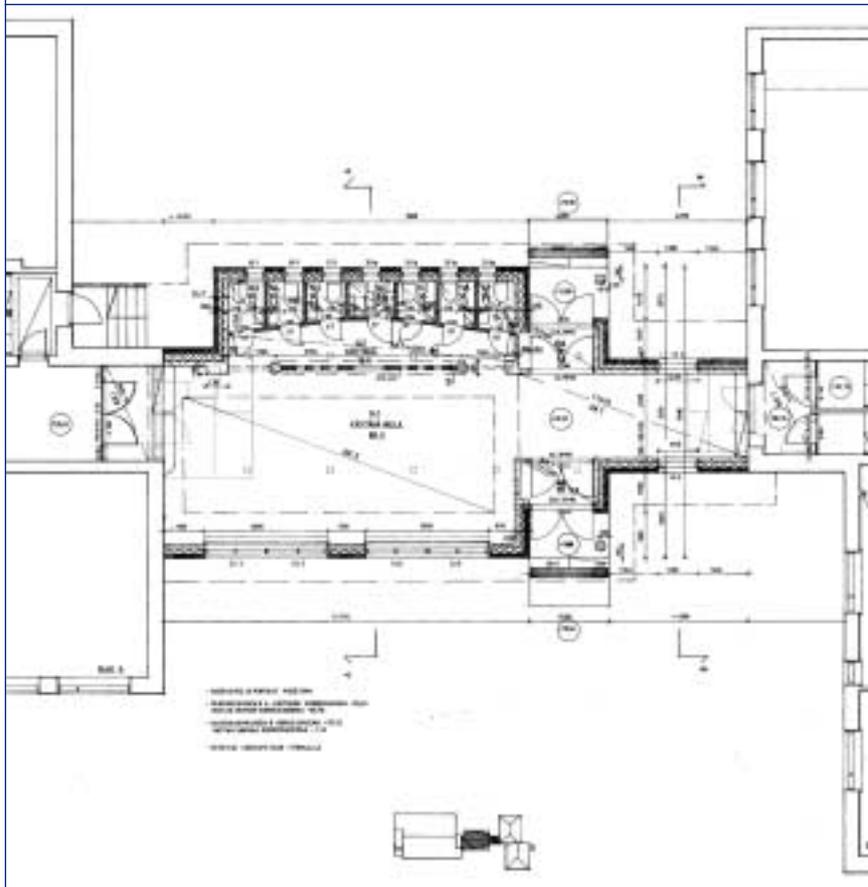
Figure 4: Floor plan: general layout of the gateway between main building and side building
