Refurbishment of the Louise Labe Secondary School, France

FR1

Annex 36: Case Study Report

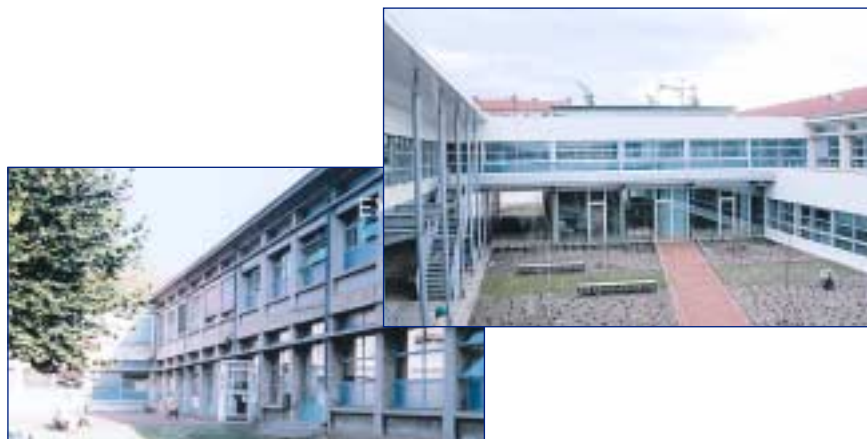
Figure 5: *Right: Patio before refurbishment*
Far right: Patio after refurbishment

- an enlarged block (2 floors) along the main road with a central corridor;
- a central open garden ("patio") around which are distributed the added rooms at the first floor (especially the large workrooms for dress-making) and whose ground floor is used partly as a covered playroom; and
- an extension of the building to connect with the gymnasium.
